B1 Heritage & History of Croft barn

THE CROFT BARN - a historical record 1581 - 2015

Summary

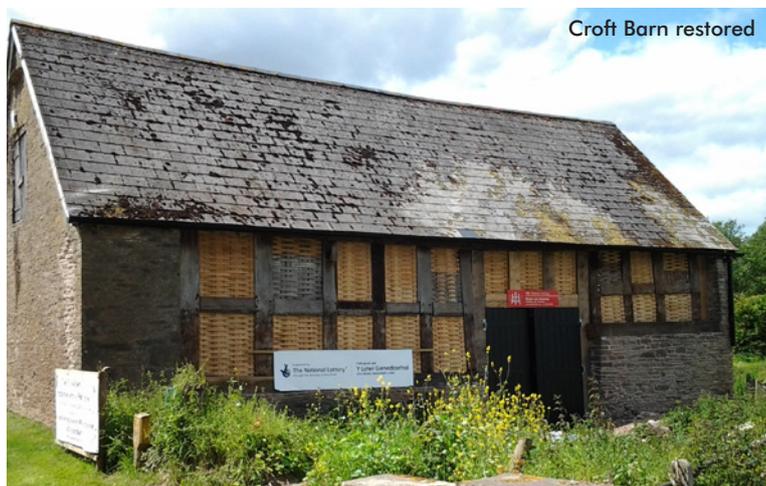
Croft Barn restored

By the early 21st century, the barn had fallen into disrepair and a condition survey carried out by Morgan and Horowsky⁹ in March 2011 recorded that the west end of the barn was completely covered with ivy, the gable walls required stitching, rainwater goods should be replaced and a considerable amount of timber framing was beyond repair. Most of the undaubed wattle panels were lost but, remarkably, a few original panels remained in situ. The conservation work undertaken in 2015 repaired the roof and masonry, replaced rotten timber framing and flagstones and remade oak lath panels where panels had been lost.

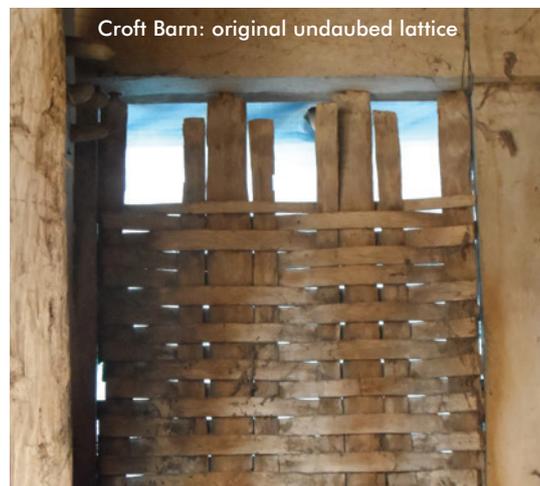
Croft Barn: original undaubed lattice

In bad weather, carts could be brought in overnight and unloaded on the following day. The primary function of the barn was to keep the crop dry, letting in plenty of fresh air at the same time. Towards this end, several devices were resorted to including panels of undaubed wattle as at Croft barn. Timber framed barns with wattle panels were common in East Wales until the 18th century, though most have now disappeared.

Many medieval barns (and houses) were cruck built, that is, their roofs rested on large curved timbers rising from floor level and meeting at the apex to form an 'A'. The Croft barn uses both cruck and box-framed trusses, which is a transitional form of building and an innovation in its time. This was clearly not undertaken because of a lack of carpentry expertise as the exceptional wood working in the cruck trusses shows. As the use of stone buildings expanded into the early 19th century, good quality timber became scarcer and decaying buildings were rebuilt with stone walls. One of the most common problems with timber framed barns was the deterioration of the gable ends which led to instability and the rotting of the timber sole plate, leading to the 'rolling over' of the vertical studs. At Croft barn, this was remedied with stone gables, but the timber sole plates were not replaced and have suffered wet rot following the loss of the oak wattle panels. These have been replaced with air-dried oak wattle, where necessary, and repaired where possible in the current restoration.

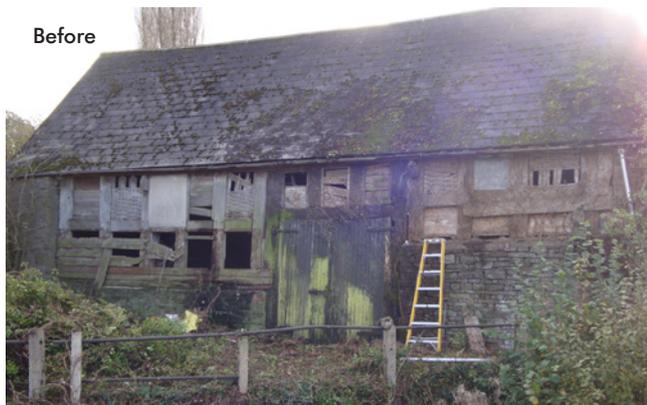
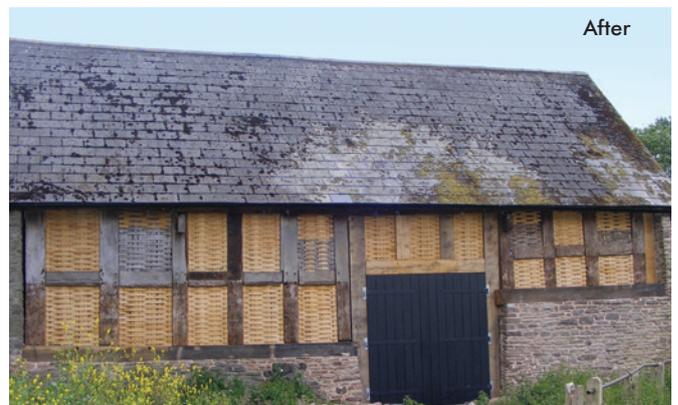
The barn is aligned approximately NW-SE and consists of four bays with large doors on either side of the long walls. The fourth truss from the west is a cruck, the other trusses being post and tie-beam, with a collar to trusses 2 and 3; the posts are jowelled. There are three tiers of purlins and an angled ridge piece. Within the barn there is a mezzanine floor accessed by an external brick stairway. Fox and Raglan’s survey of 1953 drew attention to the mix of massive cruck and box frame timbers to support the roof and the remnants of undaubed lath panels in place of windows. In the 1960s when the barn was in the ownership of the local authority, one undaubed panel was placed with Monmouthshire museum service for safe keeping, but the ‘panel’ is simply some pieces of weathered wood now and not worthy of display.

The Croft Barn, Llanvetherine, Monmouthshire, Wales, stands 150 yards south of the Abergavenny – Skenfrith B4521 road adjacent to the road leading to White Castle (Cadw). The barn was listed⁶ by Cadw in 1953 “highly graded II* as a well preserved and exceptionally rare example of a C16 cruck framed barn with exceptionally fine carpentry”. The listing states that it is “an important timber-framed barn of c.1550, first recorded by Fox and Raglan⁷. The original barn was probably wholly timber-framed and the stone gables added later. The W gable has subsequently been rebuilt and the barn on this side shorted. This barn at Great Trethiw⁸ illustrates a late development in cruck-truss tradition where crucks alternate with framed trusses in the same building. Fox and Raglan suggest that at this late phase crucks are no longer truly functional, the weight of the roof being largely carried on the stout box-framed walls... Gables and lower part of long walls are rubble stone; asbestos tile roof. Upper part of each long wall is timber-framed and has two tiers of large square panels. On N side timber panels are mostly exposed, and include (below eaves) rare-surviving oak stave and lattice panels.”

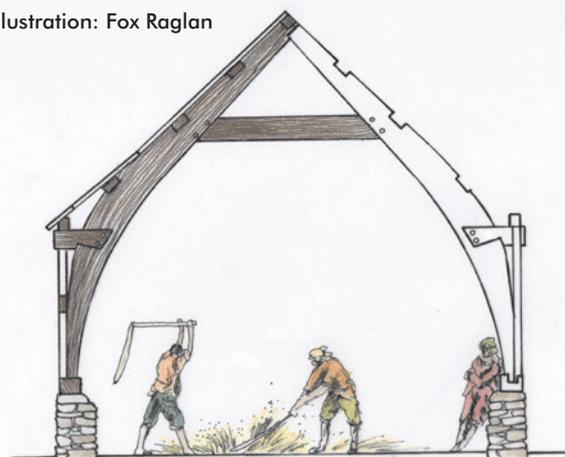
Corn Barn at Croft Farm

Cross-section showing cruck-truss 'A' on plan

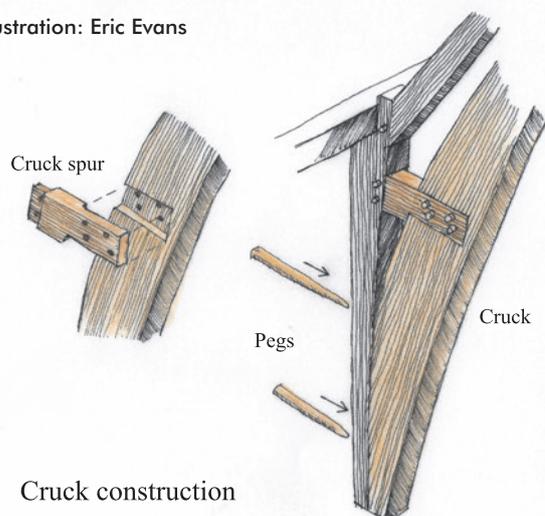
Cruck construction
